Manhole Inspection Summary

Manhole # S51O__002MH

Insp Date: **9/3/08 2:15 PM**

Location Address: **2827 elliott st**

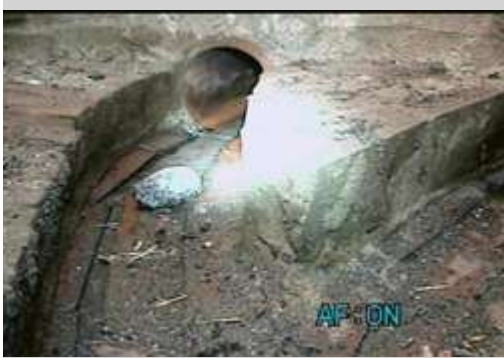
channel debris

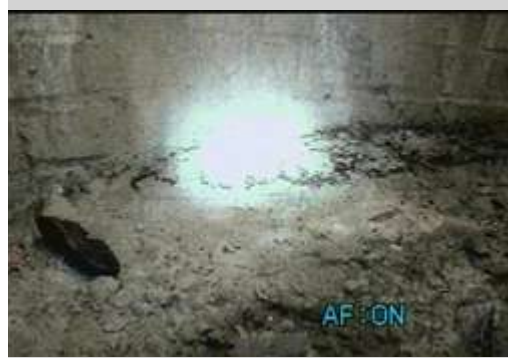
Defect 2

Condition: ☐ Sound ☐ Cracked ☐ Root Intrusion ☐ Deteriorated ☐ Leaks ☒ **Debris**

bench debris

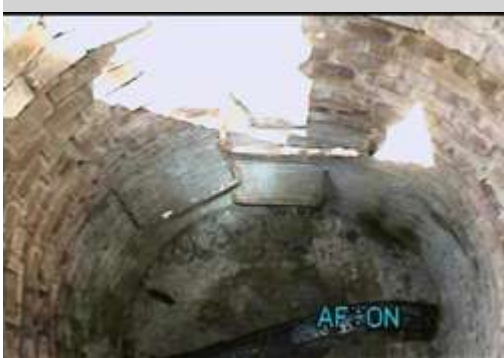
Defect 1

Count: **3** Missing: **0** ☒ **Corroded**

corroded steps

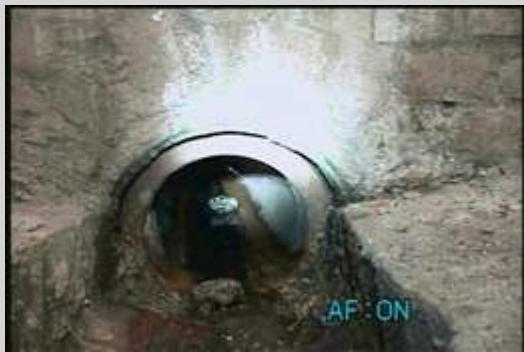
12 O'Clock Outflow

8 in. Circular Gravity Sewer
Pipe Out @ 12 O'Clock

Deposits: ☒ None ☐ Mud ☐ Sludge ☐ Debris ☐ Grease

Infiltration: **None** Pipe Seal Cond: **Unknown**

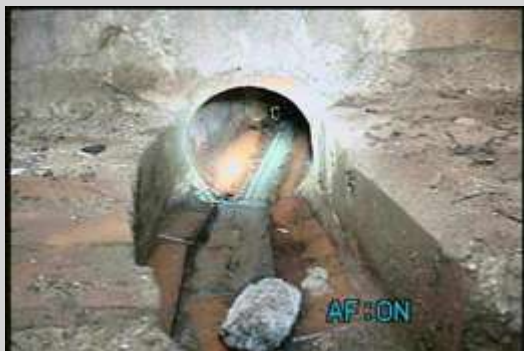
6 O'Clock Inflow

8 in. Circular Gravity Sewer
Pipe In @ 6 O'Clock

Deposits: ☒ None ☐ Mud ☐ Sludge ☐ Debris ☐ Grease

Infiltration: **None** Pipe Seal Cond: **Unknown**

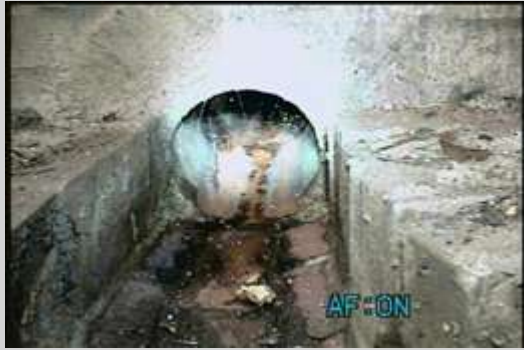
8 O'Clock Inflow

8 in. Circular Gravity Sewer
Pipe In @ 8 O'Clock

Deposits: ☒ None ☐ Mud ☐ Sludge ☐ Debris ☐ Grease

Infiltration: **None**
